**Indooroopilly Bridge Duplication**

**Geotechnical Investigation:**

**Desktop Review**

**Reference:**  
*210639FR001Atw*

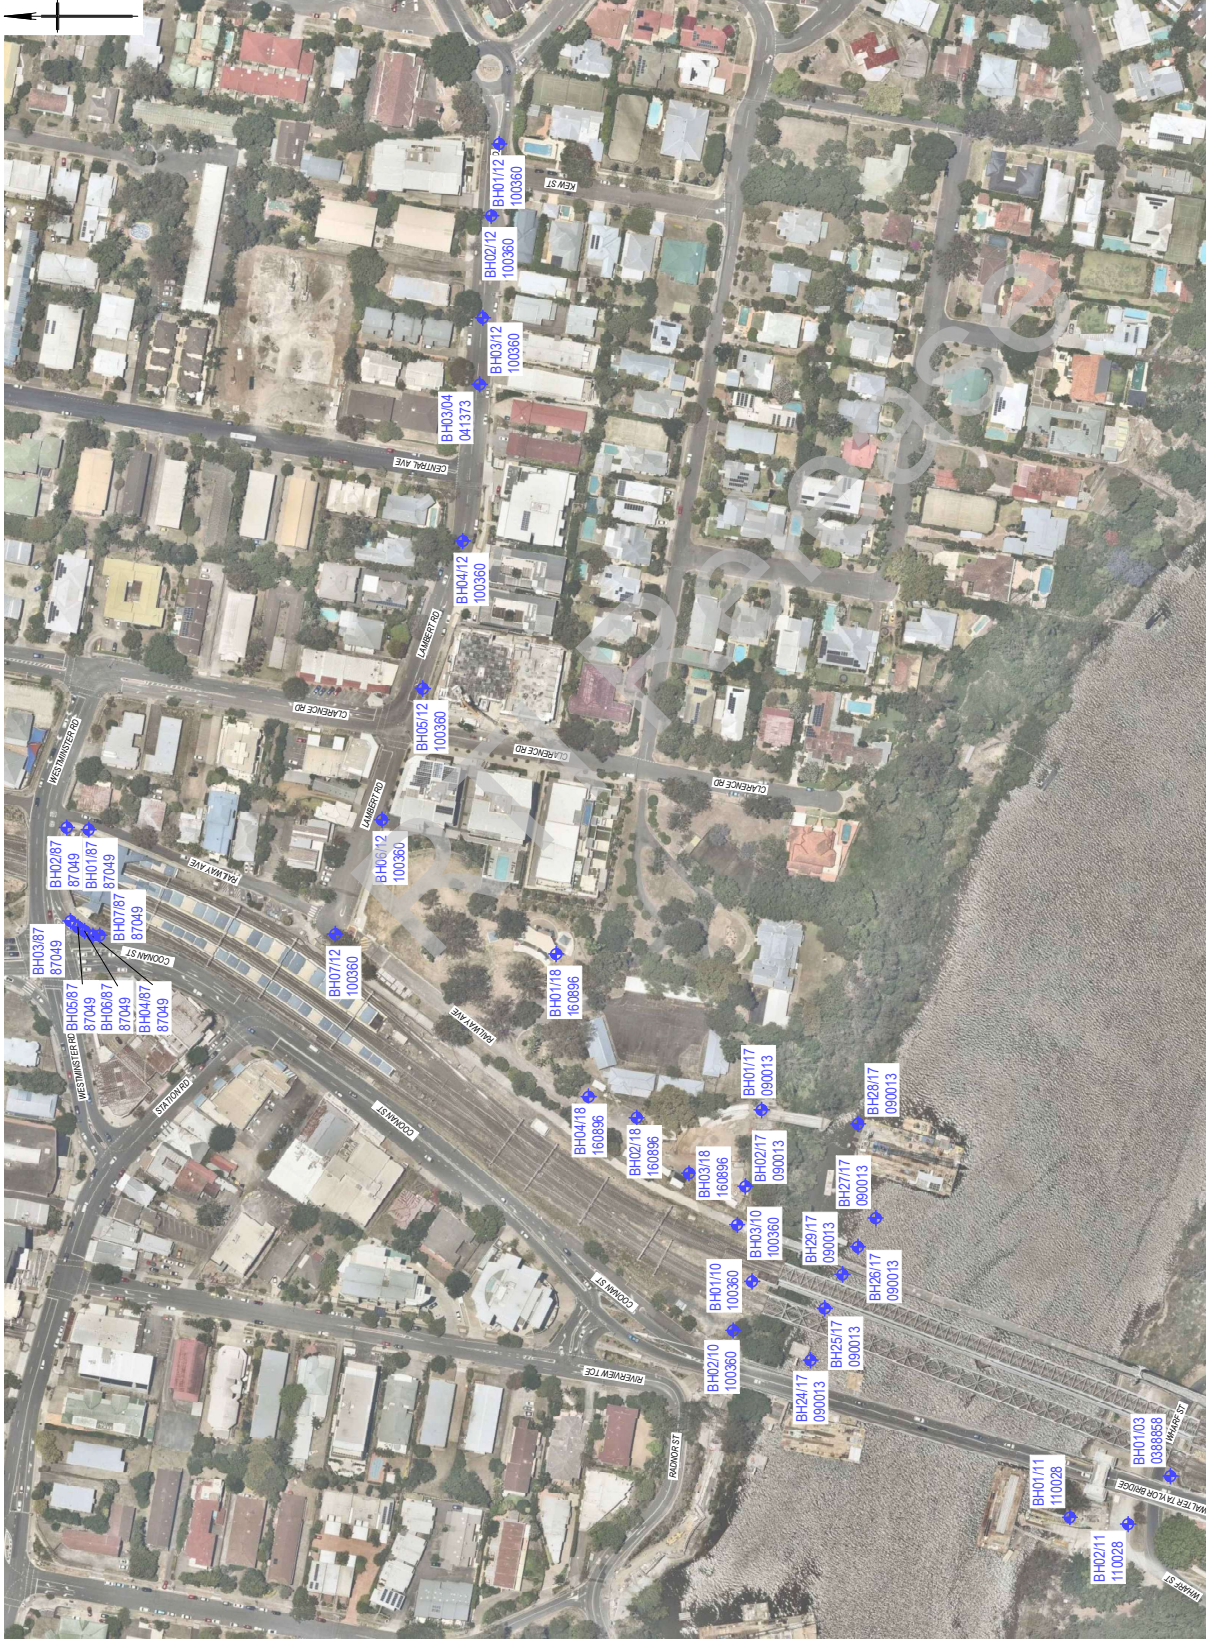
**Figure 1**                      Borehole Location Schematic

**LEGEND:**  
BOREHOLE LOCATION - PREVIOUS INVESTIGATIONS

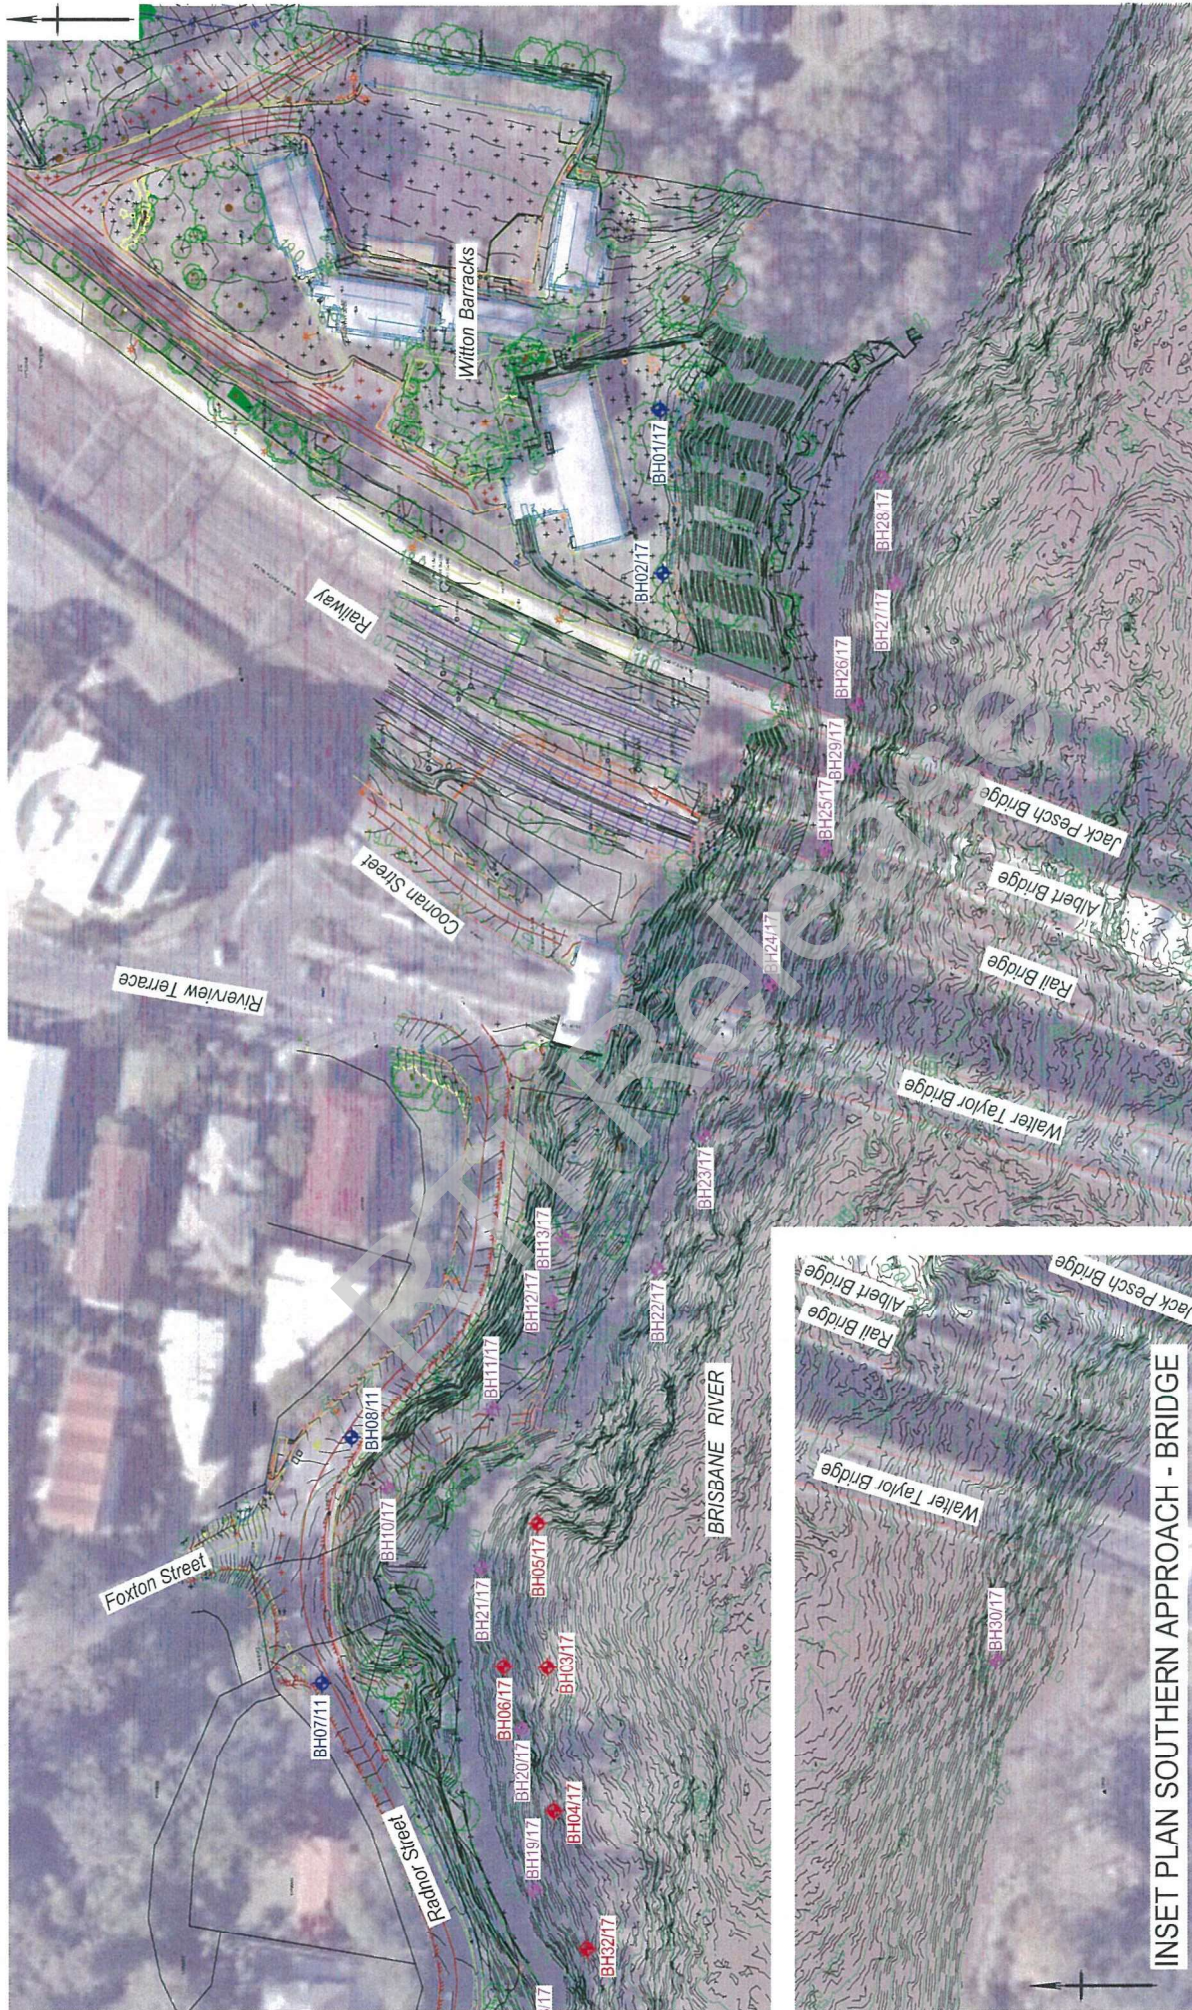
**INSET PLAN SOUTHERN APPROACH - BRIDGE**

- LEGEND:**
- ◆ BOREHOLE LOCATION - CURRENT INVESTIGATION 2017 FR003A
  - ◆ PROPOSED BOREHOLE LOCATION ARMP
  - ◆ BOREHOLE LOCATION - PREVIOUS INVESTIGATION 2017 FR002A
  - ◆ BOREHOLE LOCATION - PREVIOUS INVESTIGATION 2011 & 2017

Boreholes BH01/17 and BH02/17 encountered a veneer of fill material over residual soil, in BH01/17 only, and weathered rock. The upper level of the rock was described as phyllite with a deep weathering profile observed in BH01/17 to 3.4 m of extremely low strength rock (as was a strength descriptor at the time). The rock strength increased to medium and high strength below 3.4 m depth with very high strength rhyolite encountered at 6.3 m depth. This rhyolite intrusive extended to the full depth of the BH01/17 of 20.51 m. In BH02/17 the phyllite rock was low to medium strength to 9.5 m depth, medium strength from 9.5 m to 14 m and high strength to 21.1 m depth. The rhyolite intrusive was encountered at 21.1 m to the termination depth of 21.83 m.

In BH28/17 a band of phyllite was observed at the base of the alluvium over the rhyolite. This was described as high and very high strength.

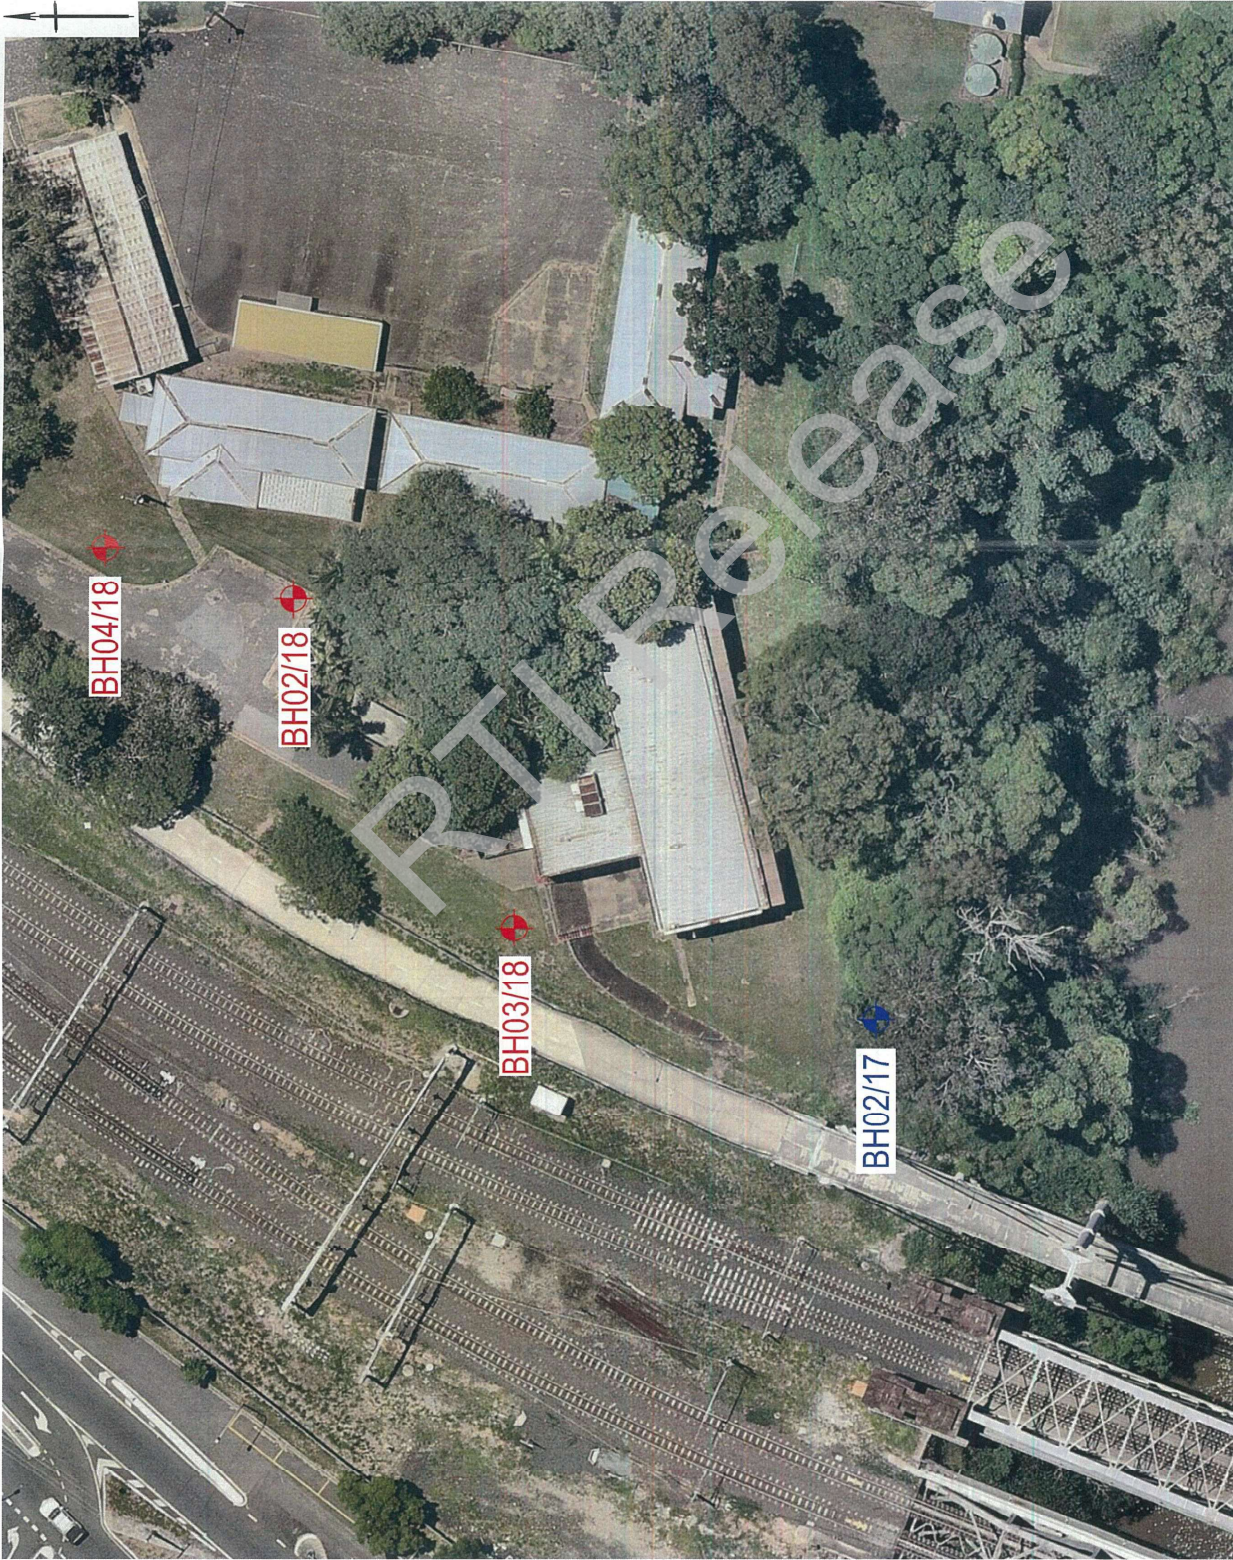
LEGEND:  
 BOREHOLE LOCATION - CURRENT INVESTIGATION 2018

The subsurface profile comprised surficial fill materials to 1.2 m over alluvial, colluvial and residual soils to full depth, with the exception of BH01/18 where phyllite was encountered at 2.3 m and also in BH02/18 where rhyolite was observed at 4.3 m depth. The upper horizons, overlying the rock comprised firm to hard sandy and silty clays.
